## REPORT ON SITE CONDITIONS

Docket 2015-AD-057, Joseph Shirer vs. Coast EPA in Pearl River Co - Electric

Prepared for the Mississippi Public Service Commission

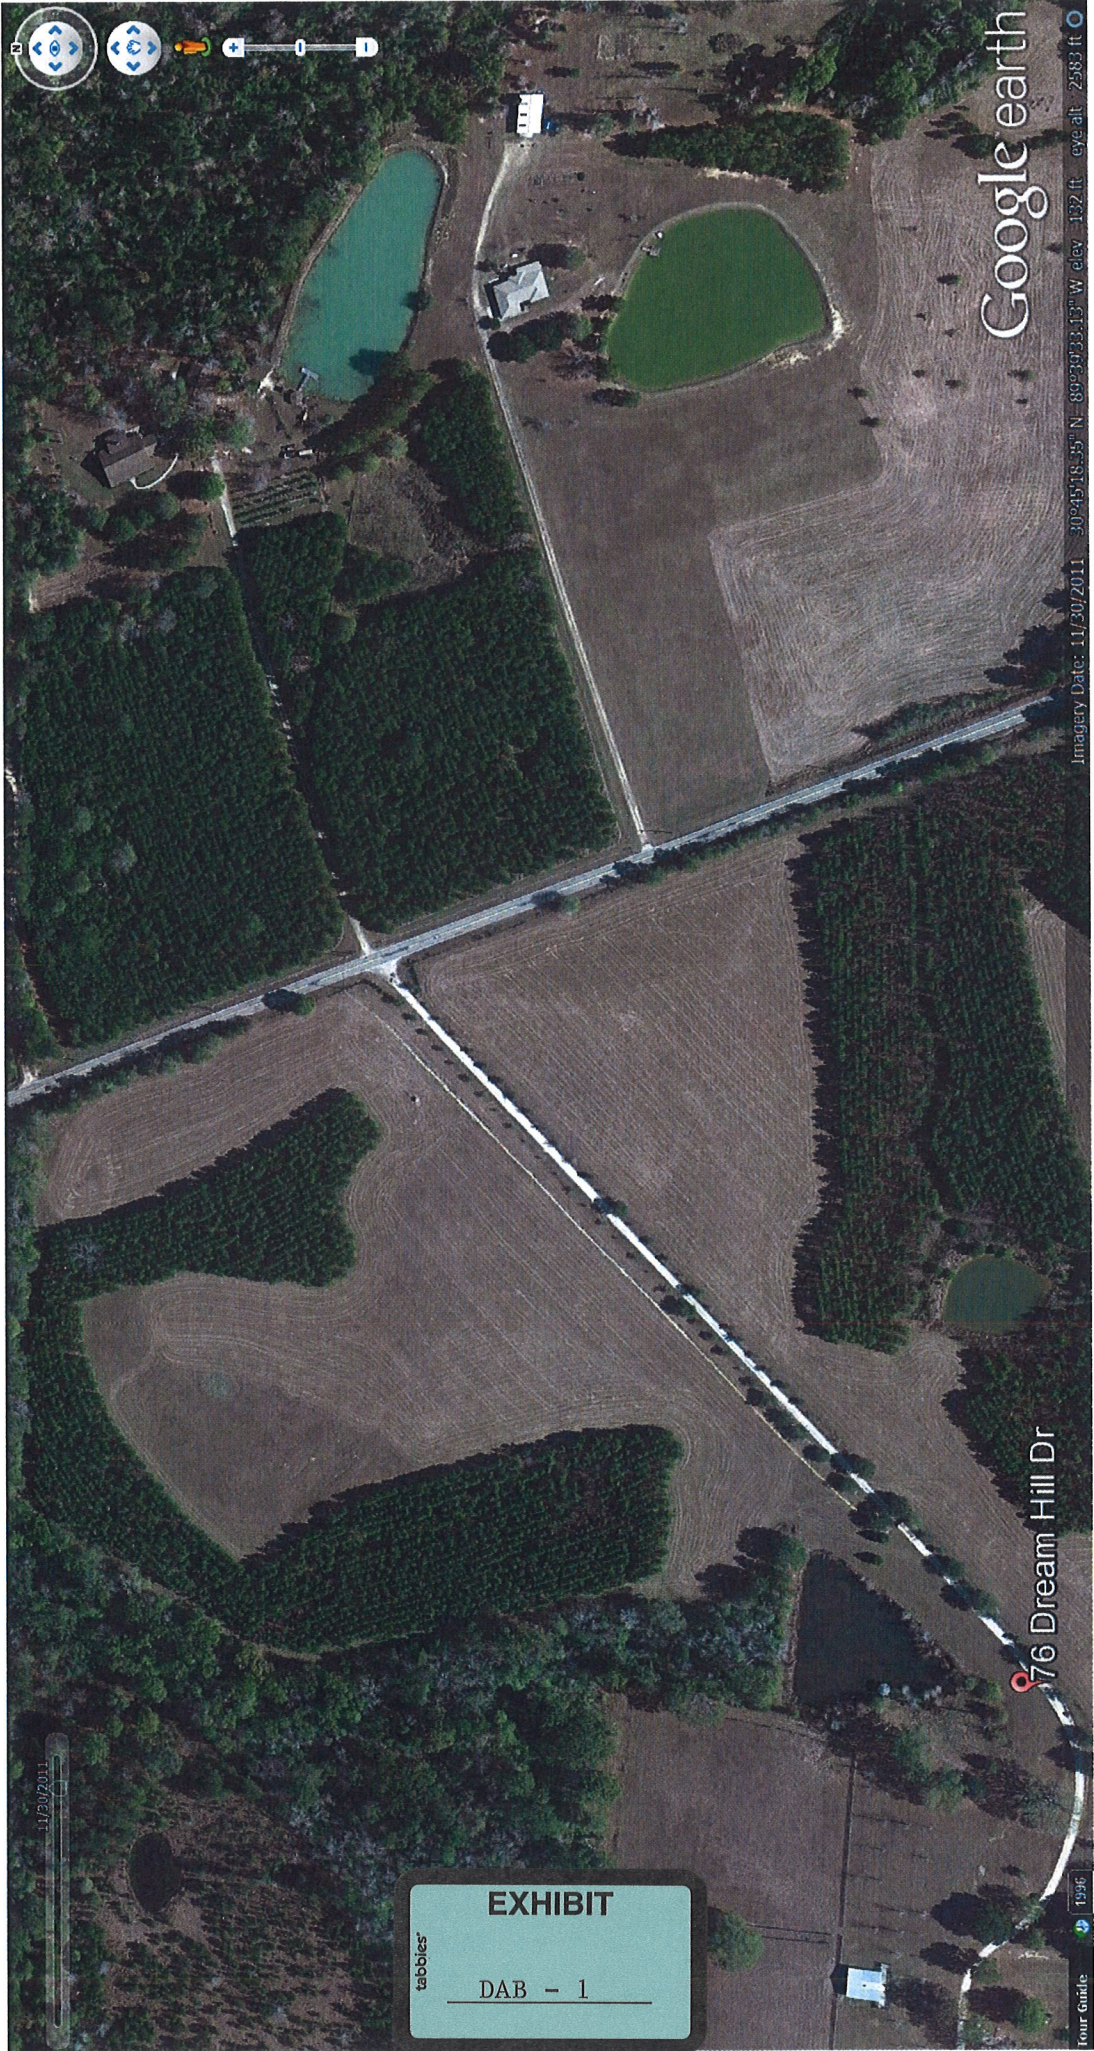
tabbles®  
**EXHIBIT**  
DAB - 1

Mr. Boackle produced a Google aerial photograph dated 2011-11-30 showing the trench, after having been backfilled. See Exhibit DAB-1 and Exhibit DAB-2. The date of this document may reflect a lag between data collection and publication to the internet. The contract between Coast and Mr. Shirer is dated approximately 8 months prior to this aerial photograph. This photograph shows the trench as straight, from the connection near the house to John Amacker (approximately 1,200 feet) and terminating at a utility pole on the west side of John Amacker Road, on or near the county right-of-way. Mr. Shirer said the photograph did not accurately depict the trench due to "curvature of the earth."

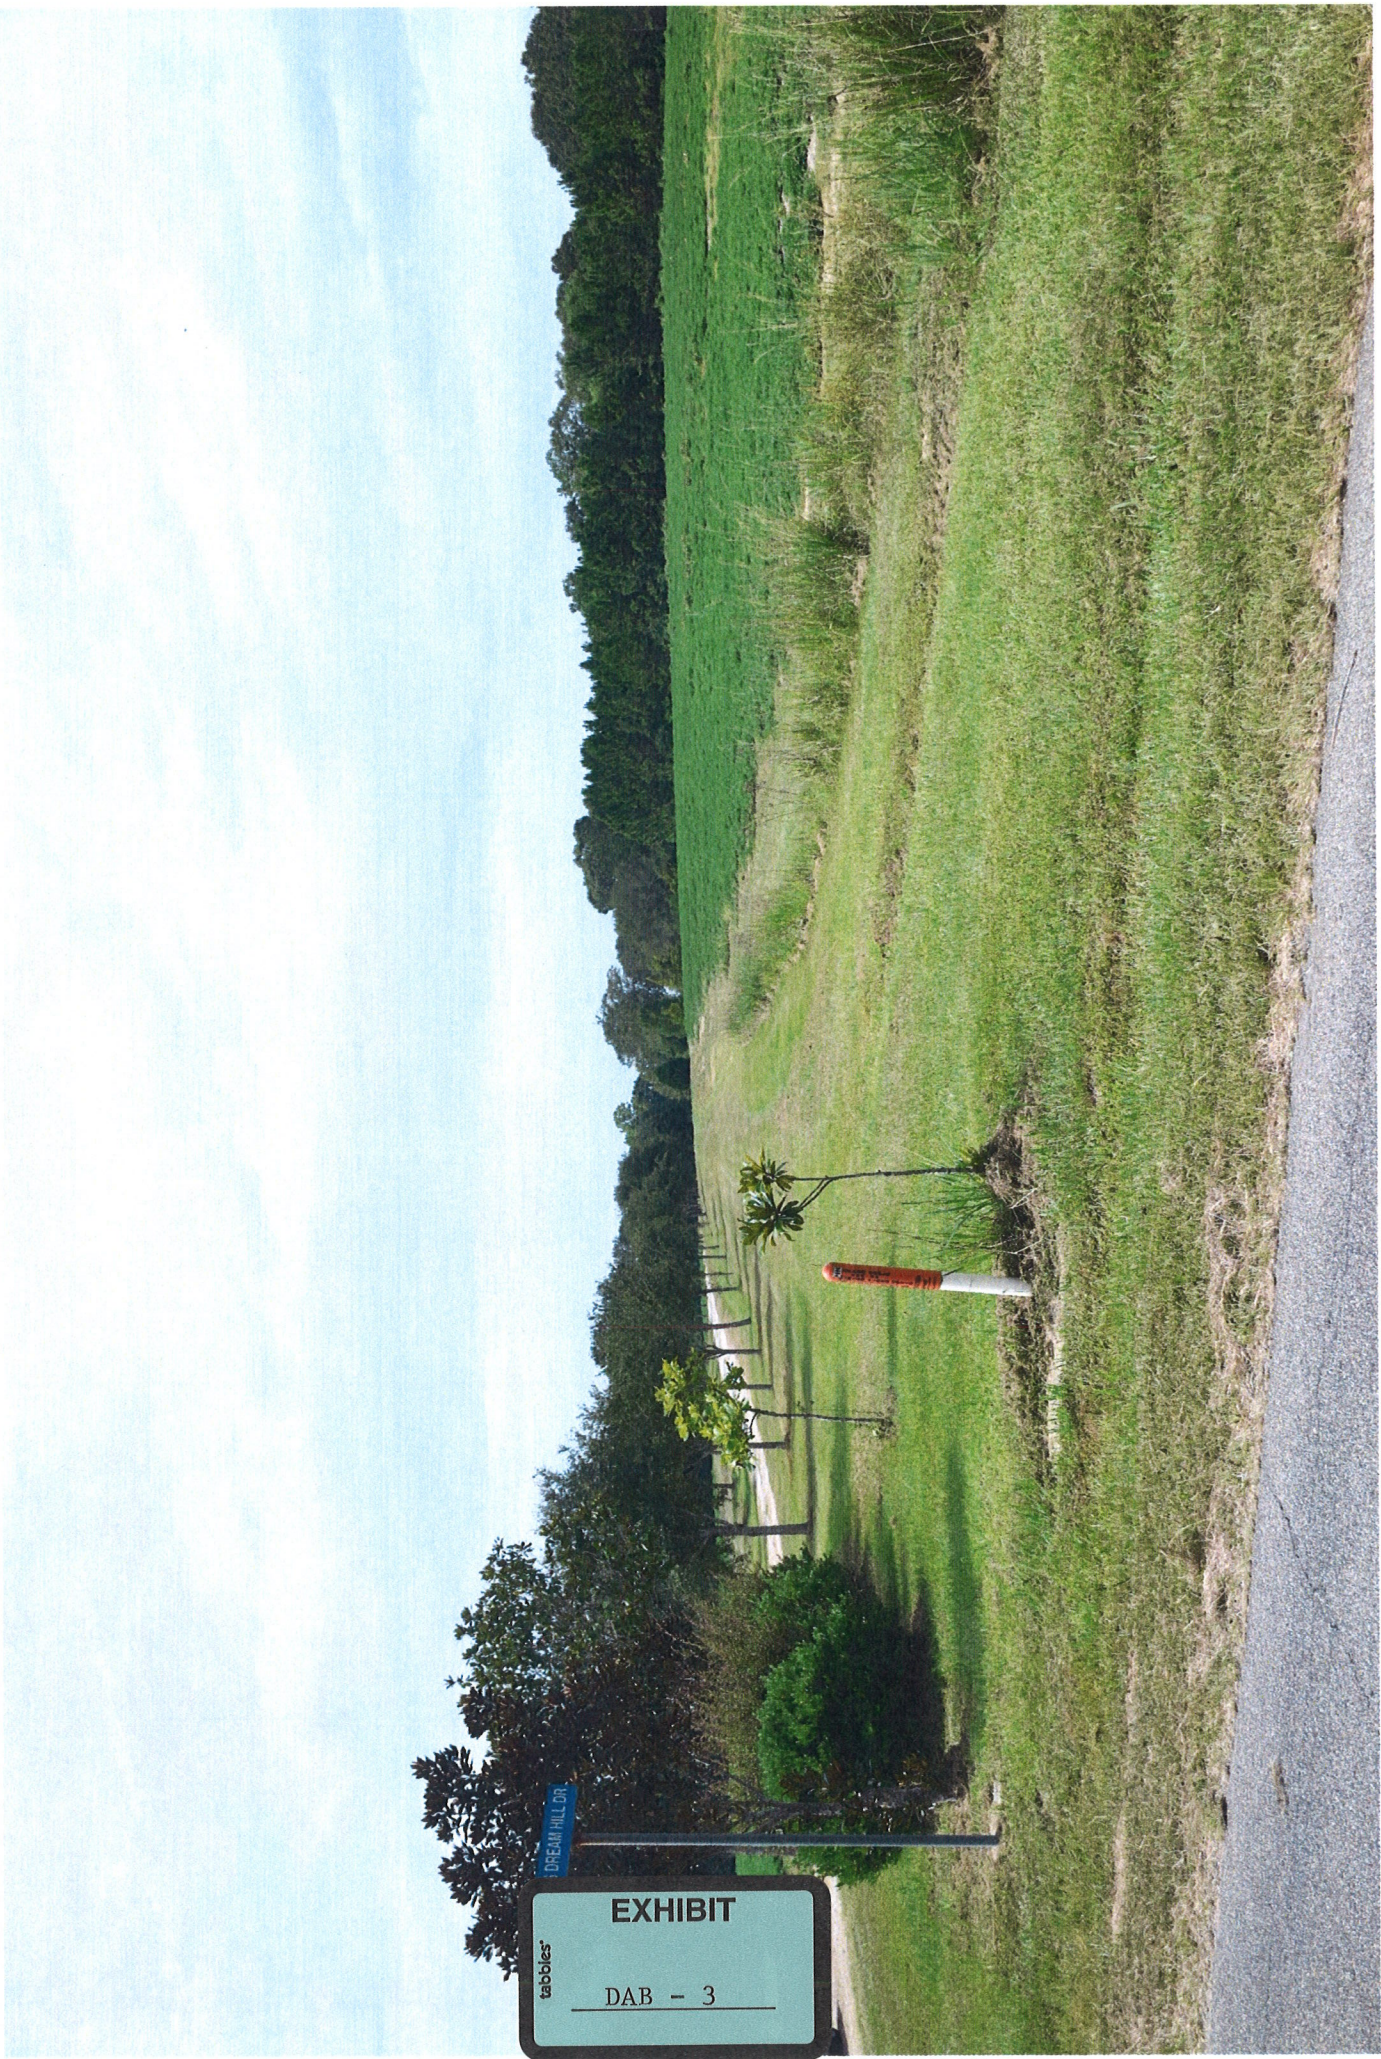
DAB - 3

There are three ditches discussed here. Two ditches are located on Mr. Shirer's property and the other on the county right-of-way. All three ditches are shown in Exhibit DAB-3.

One of the ditches on Mr. Shirer's property, constructed by the county, begins roughly parallel to Dream Hill and, moving east, curves left about 90 degrees to become parallel to John Amacker. It is shallow, with gradually sloping sides. The other ditch on Mr. Shirer's property was constructed by Coast, just north of the county ditch.

Both ditches on Mr. Shirer's property are fully grown over with grass and vegetation. There are no signs of erosion in these ditches.

Pearl River County maintains the third ditch, in their right-of-way, along John Amacker Road. This ditch appears to gradually slope to the north. It is well maintained and there are no significant signs of erosion.

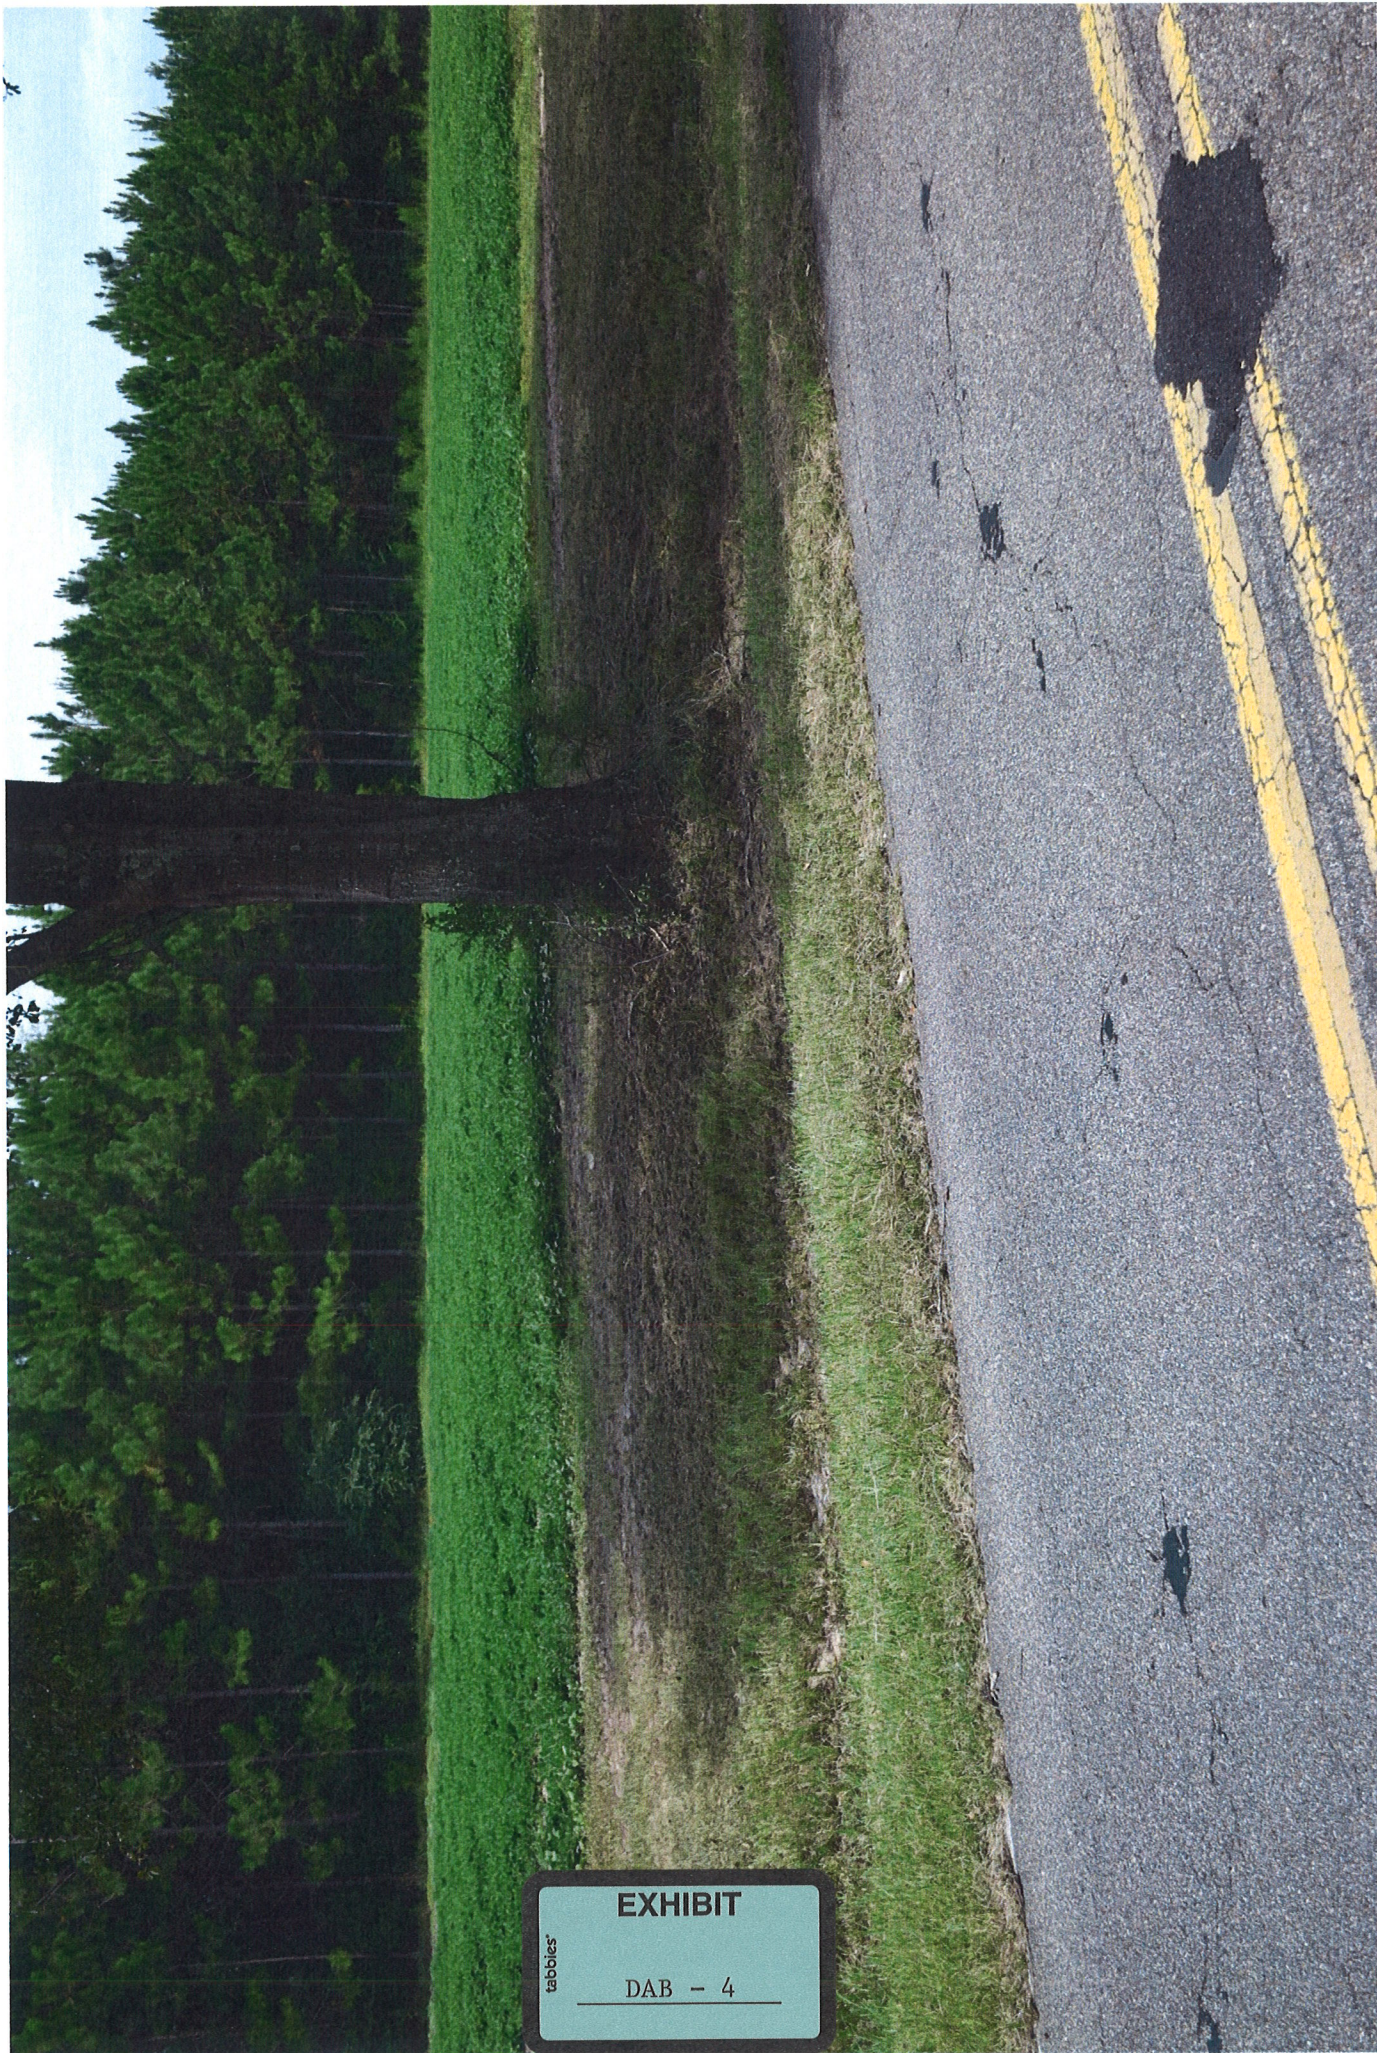
DAB - 4

Approximately 80' north of Dream Hill, there is a tree which is halfway on Mr. Shirer's property and halfway in the county right-of-way. This is the only tree referenced in this report. The tree's roots swell the surrounding ground and create a small mound in the county ditch. After a rain, some water may collect in the county ditch, south of the tree roots. Mr. Shirer indicated to Mr. Ray that this tree should be removed and work done to improve drainage in this area. See Exhibit DAB-4.

The tree partially in the county right-of-way was discussed in this meeting with Mr. Dungan and Mr. Lumpkin. Both Mr. Dungan and Mr. Lumpkin said they are willing to write a letter that they have no objection to Mr. Shirer removing the tree. This may have to be voted on by the Board of Supervisors.

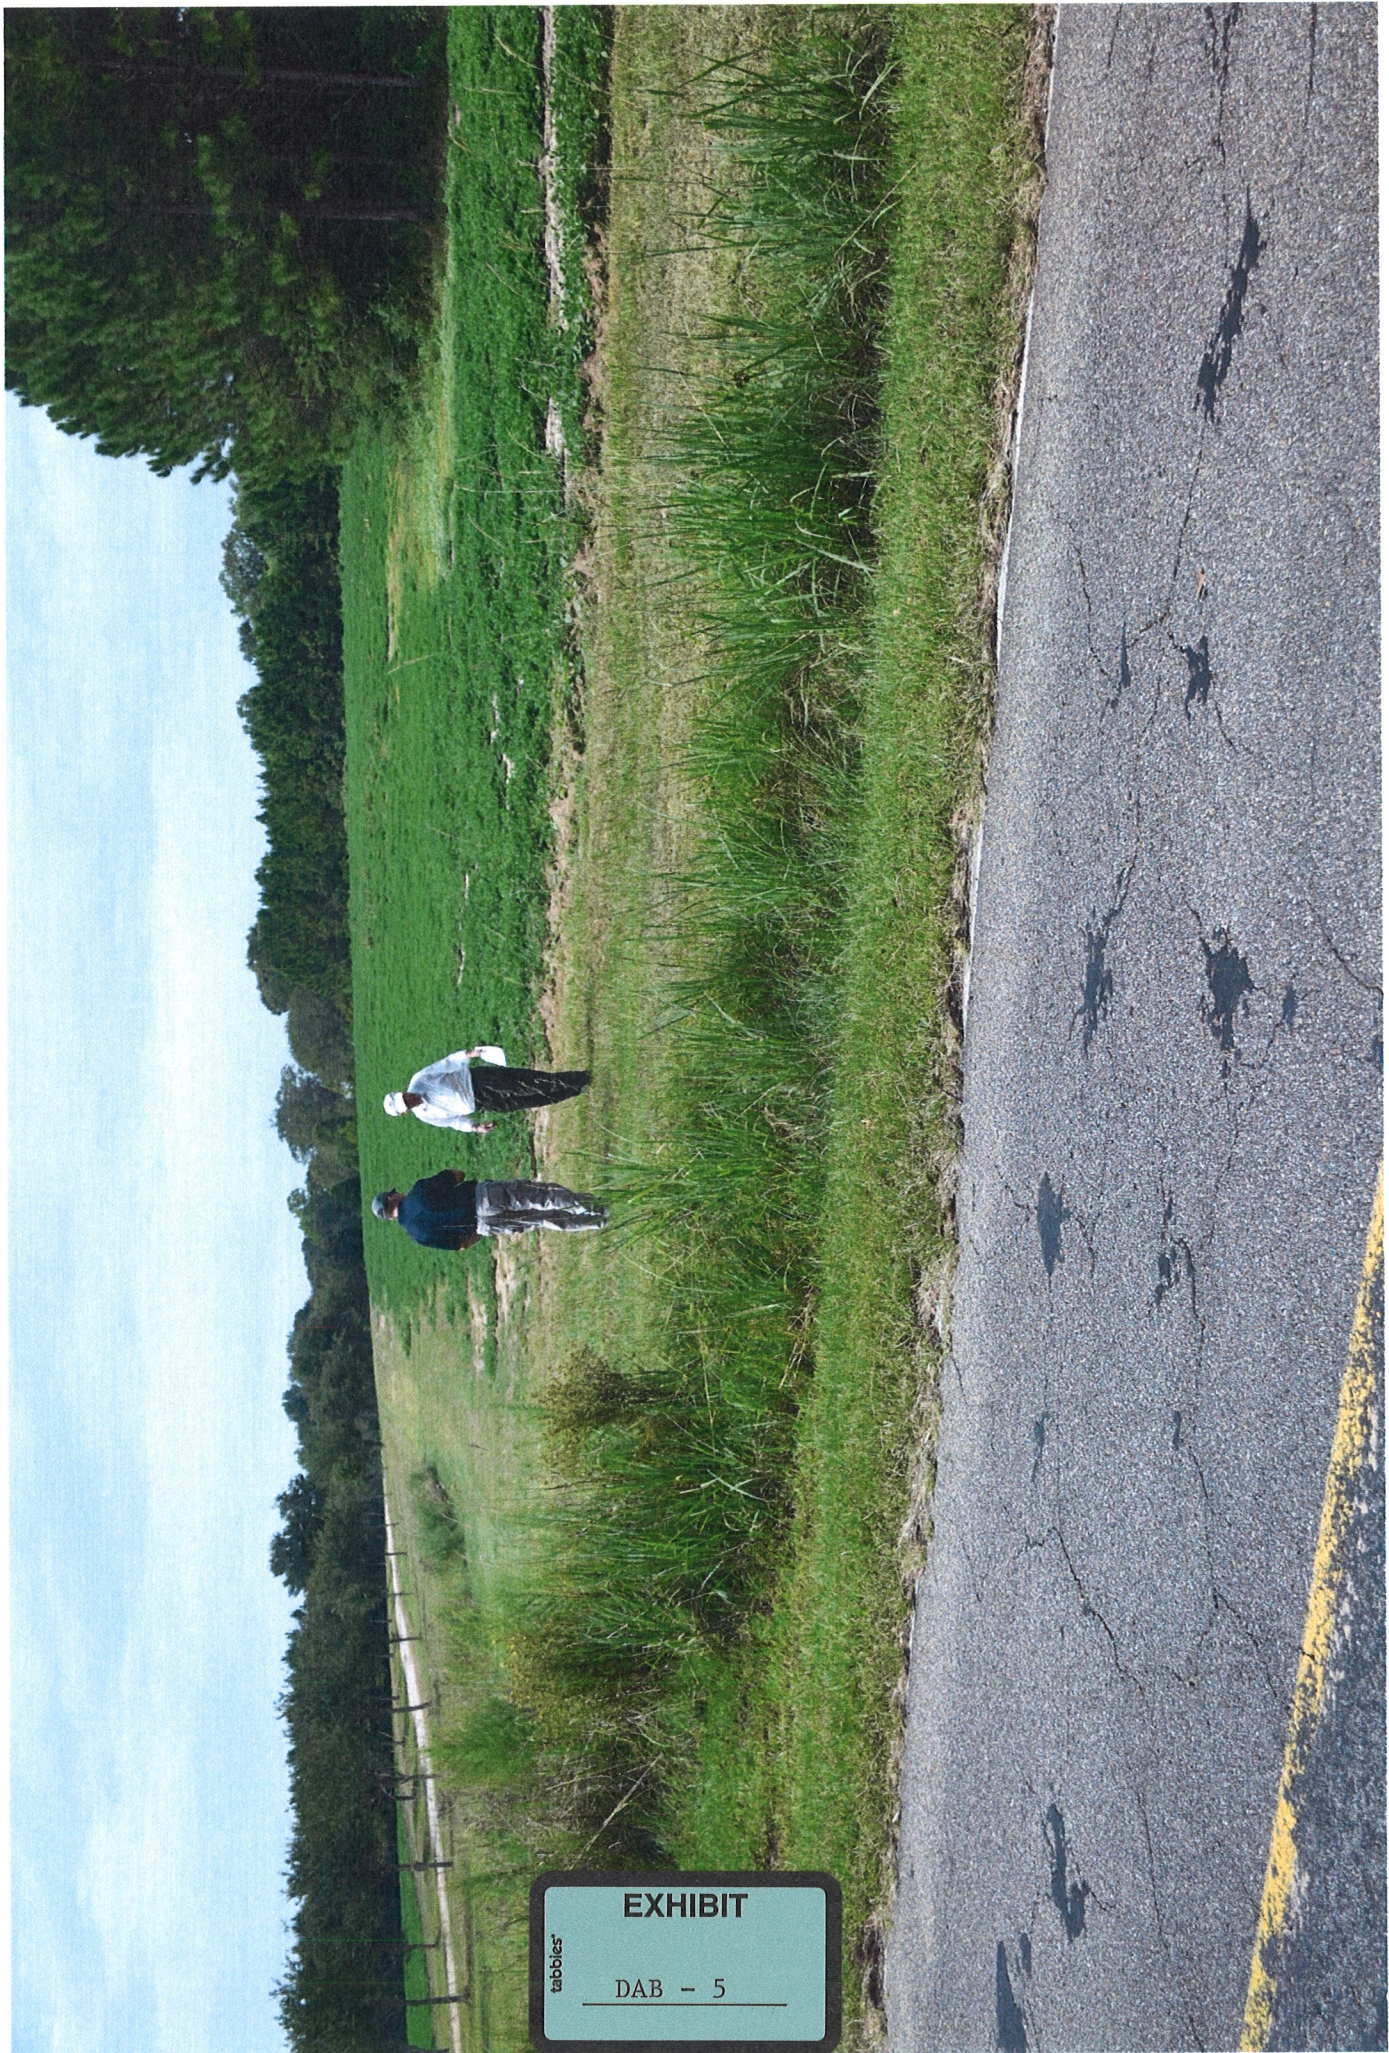
DAB - 5

In his claim, Mr. Shirer states, "..there is a severely damaged area of approximately two acres..." Mr. Boackle asked Mr. Shirer to locate this area for the parties. Mr. Shirer pointed to the Coast ditch. In this ditch, the vegetation is well established, covering the bottom of the ditch as well. See Exhibit DAB-5 for an overview and Exhibit DAB-6, where Mr. Boackle has knocked down some grass and stepped into the Coast ditch, finding the bottom well packed and hard.

Calculating the unmowed area around this ditch, including some area on either side of the ditch itself, the area is approximately 1-1/2 feet wide (average) by approximately 100 feet long = 150 square feet. This is the only area Mr. Shirer pointed out to us as being damaged.

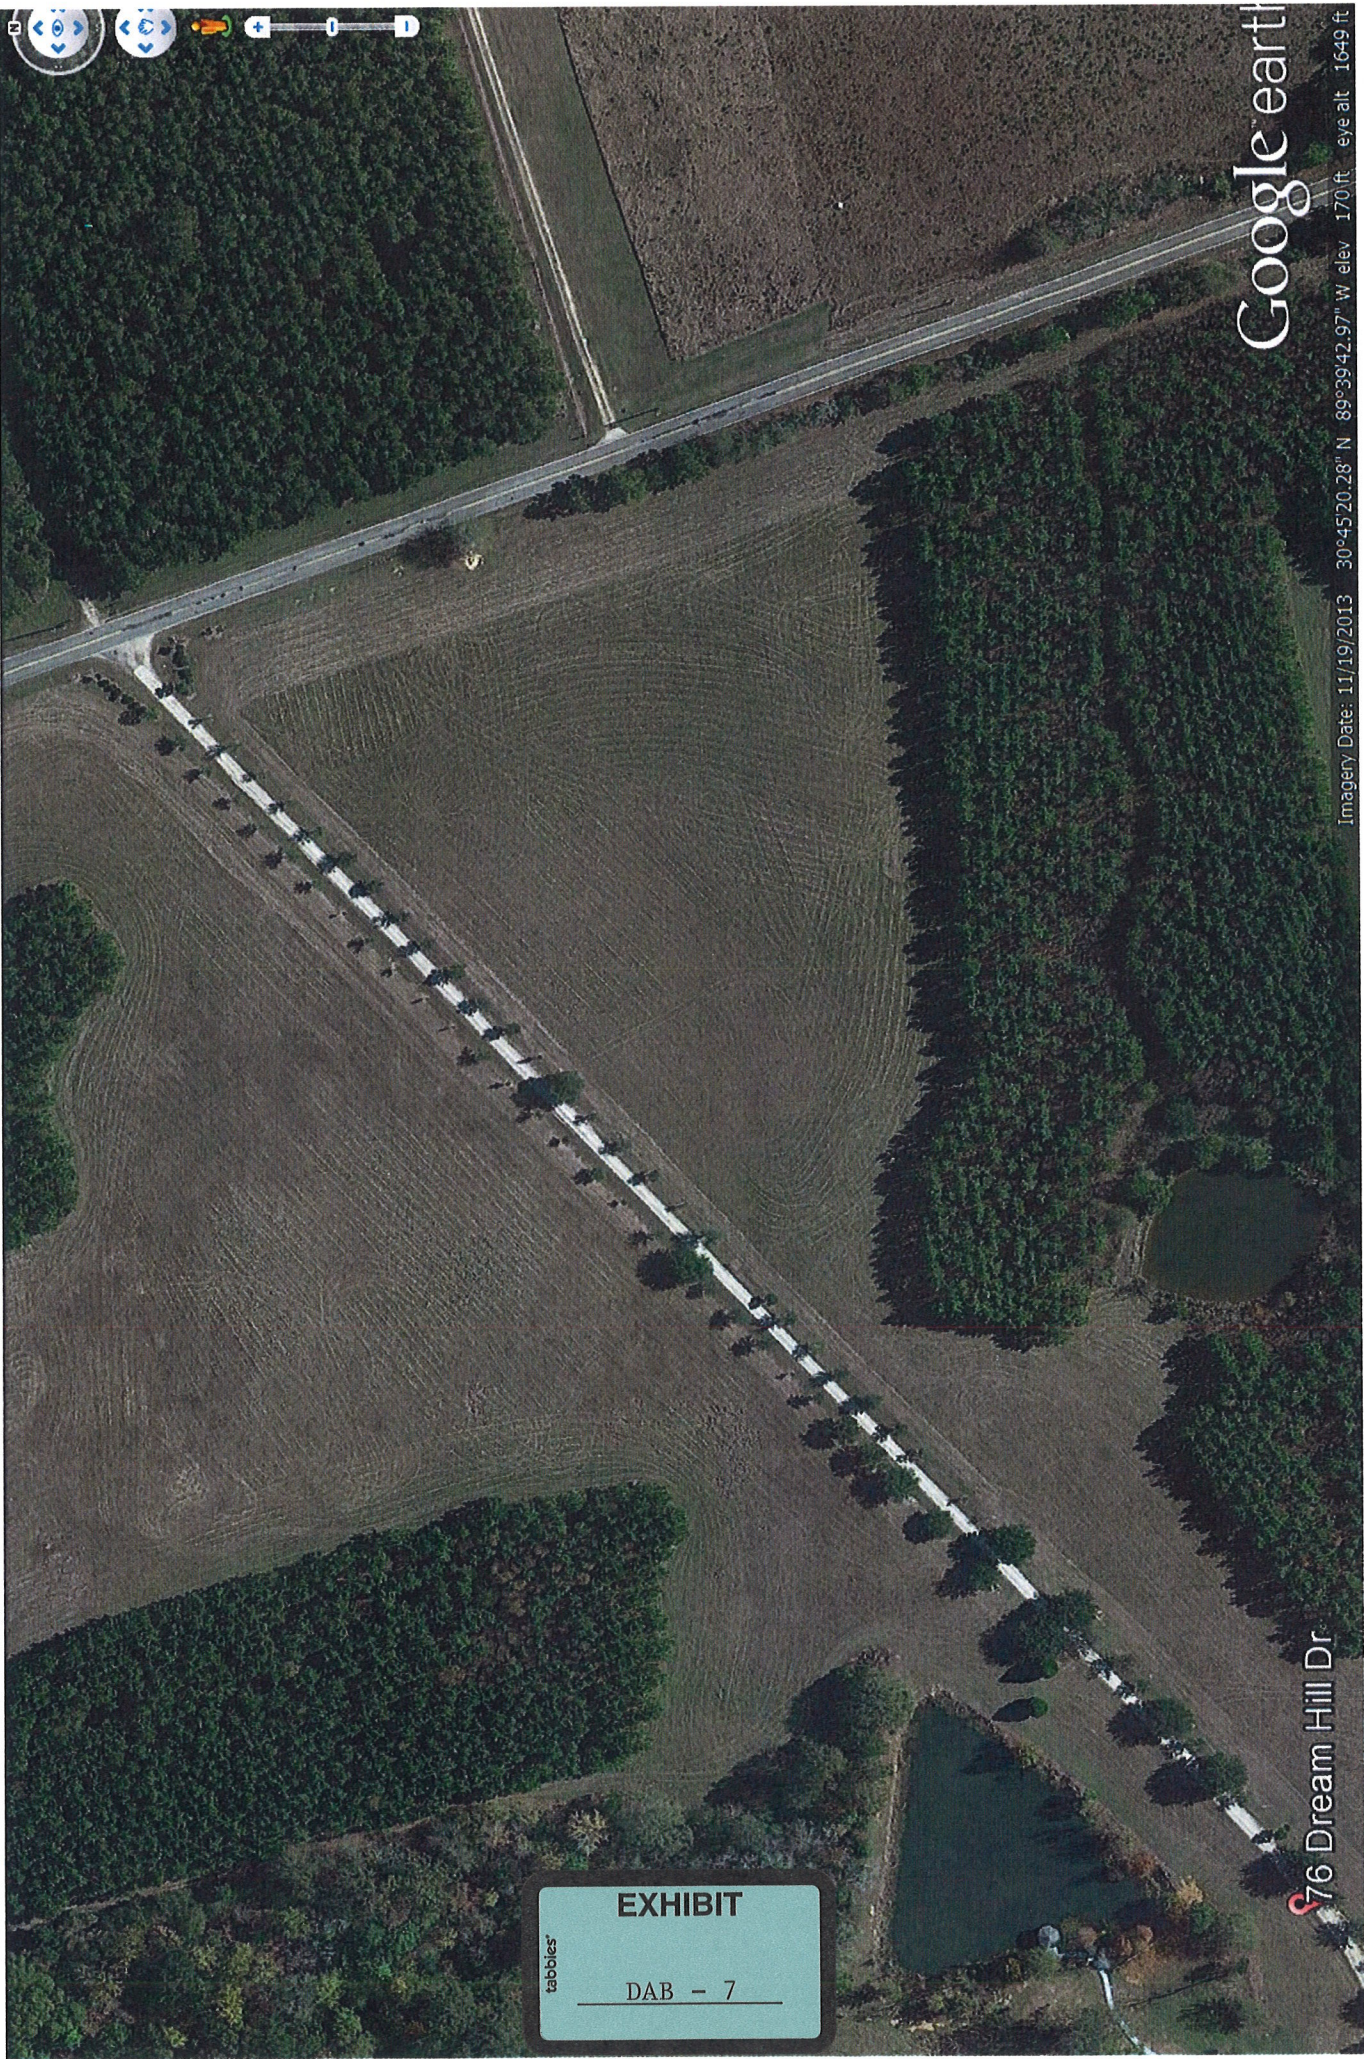
tabbles<sup>®</sup>  
**EXHIBIT**  
DAB - 7

Currently, this area is experiencing unusually dry conditions. To check for erosion or other damage in the recent past, we have an aerial photograph from 2013, which shows the trench was grown over and has been mowed or used for farming at the time the image was captured. See Exhibit DAB-7.

The photograph from 2013 appears to show the ground was healed even then. This indicates that not only is there not a problem now but there has not been a problem for a number of years.
